**United States Environmental Protection Agency
Criminal Investigation Division
Investigative Activity Report**

Fortymile: [REDACTED] Placer Mine Investigation
(APMA [REDACTED])

Mine Discharge Investigation at the APMA [REDACTED] Mine
(08/19/13)

Mine Discharge Investigation at the APMA [REDACTED] [REDACTED] Mine (08/19/13)

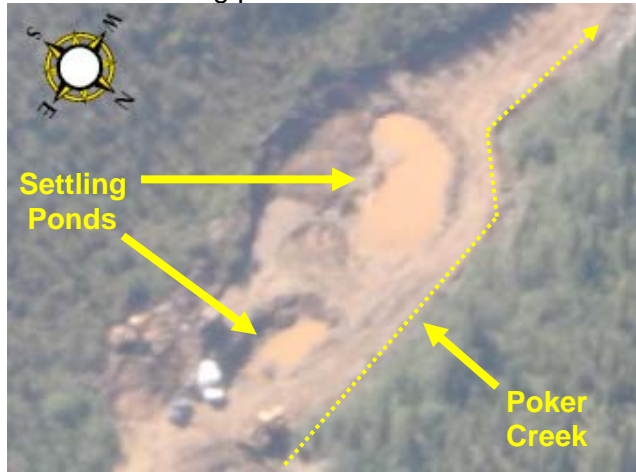
Photograph 1 was taken on 08/01/13 at approximately 2:26PM and depicts two adjacent settling ponds at the mine along Poker Creek. At the time of field investigation on 08/19/13, only the larger of the two ponds remained. It was this larger settling pond that was found to be discharging on 08/19/13. **Photograph 2** was taken on 08/01/13 at approximately 2:28PM and depicts the [REDACTED] mine camp, located approximately one-half mile downstream from the settling ponds. The audio-recorded field contacts of mine laborer [REDACTED] on 08/19/13 occurred at the mine camp.

Photo 1: Settling ponds on 08/01/13

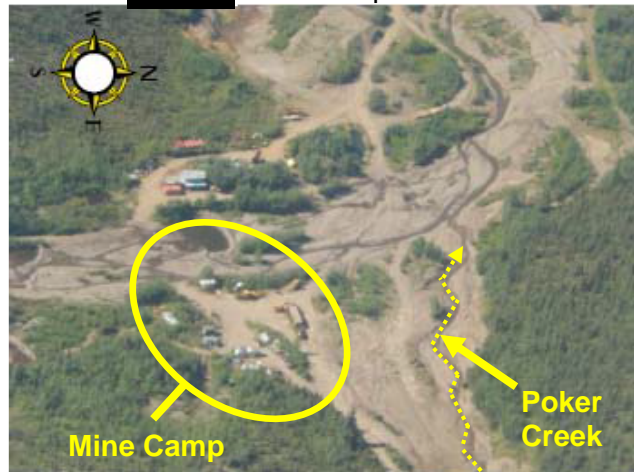
Photo 2: [REDACTED] mine camp on 08/01/13

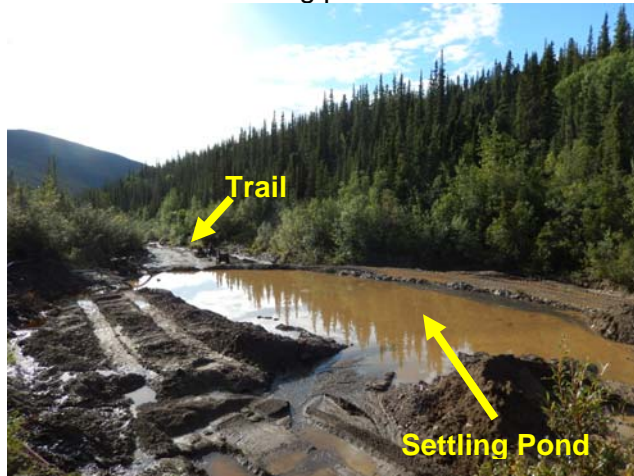
Photograph 3 was taken on 08/19/13 at approximately 5:35PM and depicts the turbid settling pond. The picture was taken facing downstream. A portion of the trail where the discharge channel eventually flowed into the creek is partially visible.

Photo 3: Turbid settling pond.

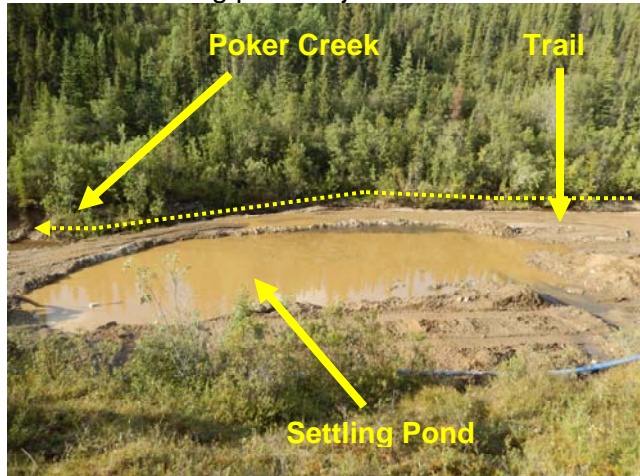
Photograph 4 was taken on 08/19/13 at approximately 5:37PM and depicts another perspective of the settling pond. A portion of Poker Creek is visible adjacent to the settling pond, separated by a berm and trail.

Photo 4: Settling pond adjacent to Poker Creek.

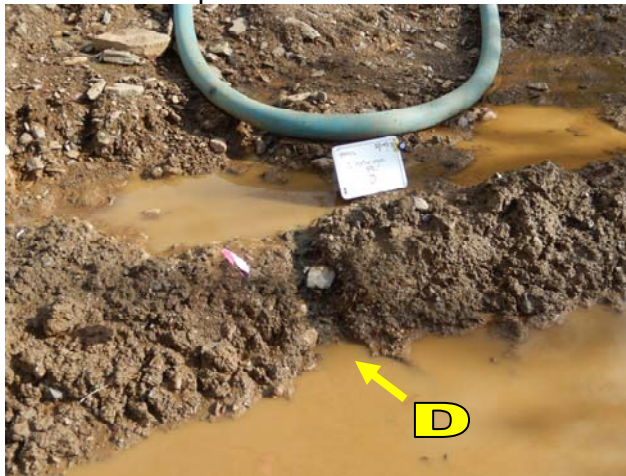
On 08/19/13 at approximately 4:42PM, Special Agent [REDACTED] collected a sample of seepage from a small pool of turbid water which was observed accumulating flow from the settling pond's berm. The accumulated seepage then formed into channels and flowed along the trail until reaching the creek. The location of this sample was designated as **Sample Station D**.⁵ As reported in Section 5 of this report, discharge **Sample D** resulted in a reading of **greater than 1000 NTUs**.

Photograph 5 was taken on 08/19/13 at approximately 4:43 PM and depicts the source location for the collection of seepage from **Sample Station D**. **Photograph 6** is a closer perspective of the previous photo and depicts turbid seepage discharging from the settling pond's berm. The pink flag was placed by Special Agent [REDACTED] for identification purposes.

Photo 5: Sample Station D outside of berm.

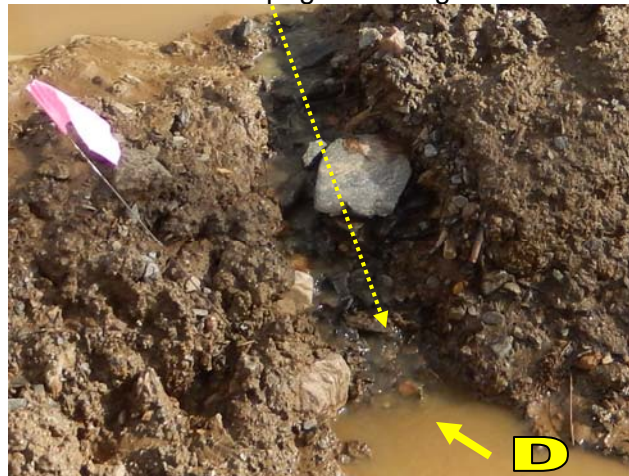
On 08/19/13 at approximately 4:43PM, Special Agent [REDACTED] observed, photographed, and video recorded⁴ turbid flow seeping from multiple locations along the western (downstream) earthen berm of the settling pond. In addition, the soils of this above-grade earthen berm appeared to be saturated. In some locations along the berm, the seepage was visible as flowing turbid water which pooled on the ground before flowing into channel(s) on the trail.

Photo 6: Turbid seepage discharge from berm.

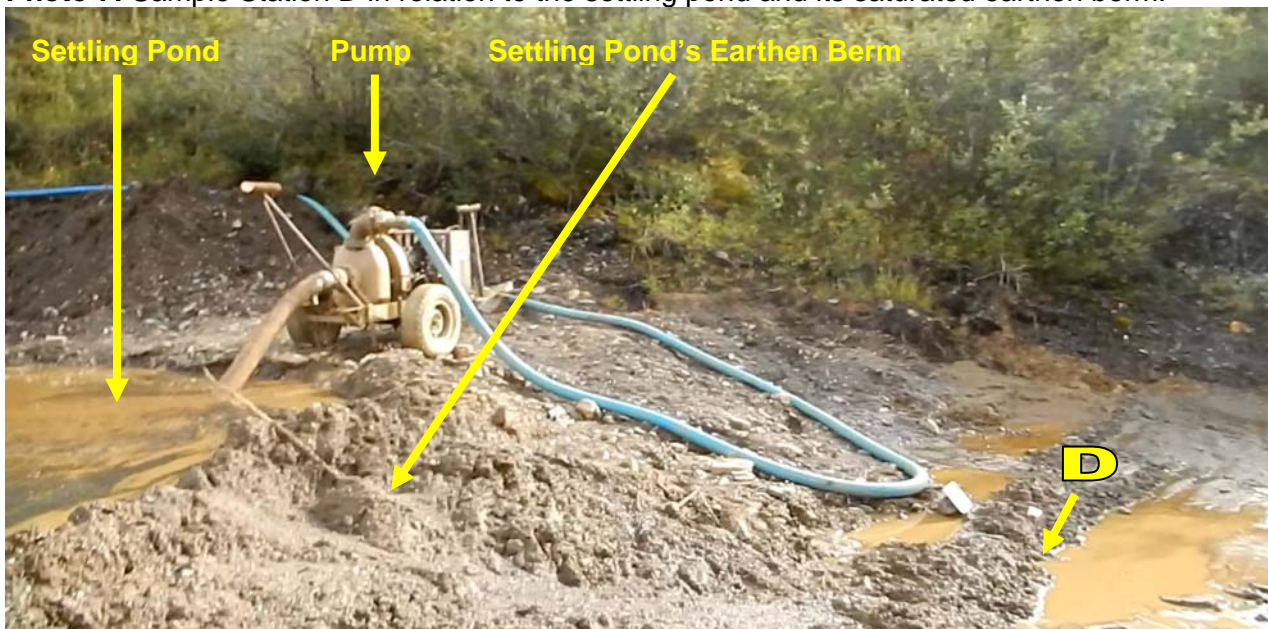
Photograph 7 represents a frame from video recording DSCN2153 taken on 08/19/13 at approximately 4:45PM. This photograph depicts the location of Sample Station D in relation to the settling pond and its (downstream) berm. The pump depicted in the picture is discussed in more detail in Section 6 of this report.

Photo 7: Sample Station D in relation to the settling pond and its saturated earthen berm.

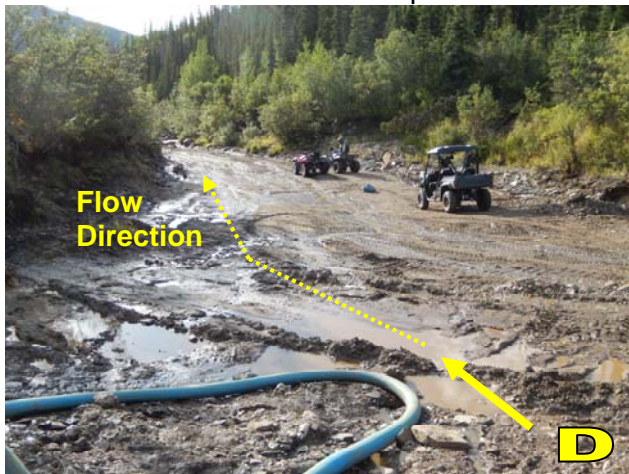
Photograph 8 was taken on 08/19/13 at approximately 5:38PM and depicts channelized turbid water flowing downstream from Sample Station D, discussed in Section 4.1. The ATV's in the picture belong to investigators.

Photo 8: Turbid flow from Sample Station D.

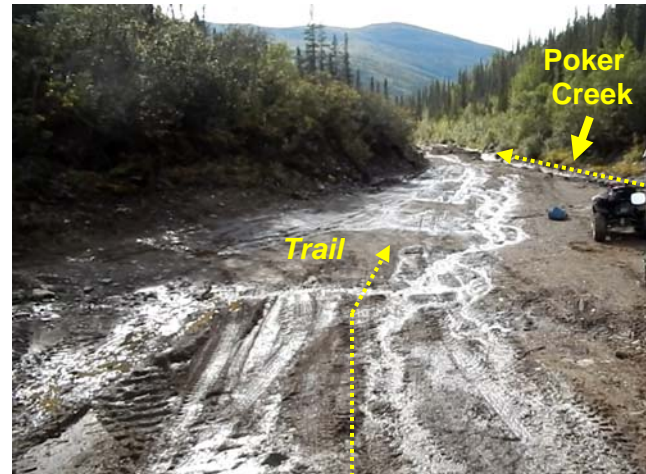
Photograph 9 represents a frame from video recording DSCN2153 taken on 08/19/13 at approximately 4:45PM. This photograph depicts another perspective of channelized turbid water flowing downstream towards Poker Creek.

Photo 9: Channelized turbid flow towards creek.

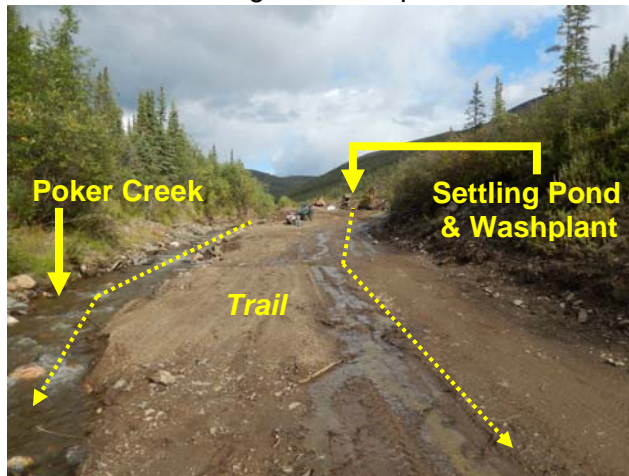
Photograph 10 was taken on 08/19/13 at approximately 4:40PM and depicts channelized turbid water flowing towards the creek. Visible in the background is a portion of the mine's washplant, which is adjacent to the settling pond. Poker Creek is seen flowing parallel to the discharge channel(s) at this point along the trail.

Photo 10: Discharge channel parallel to creek.

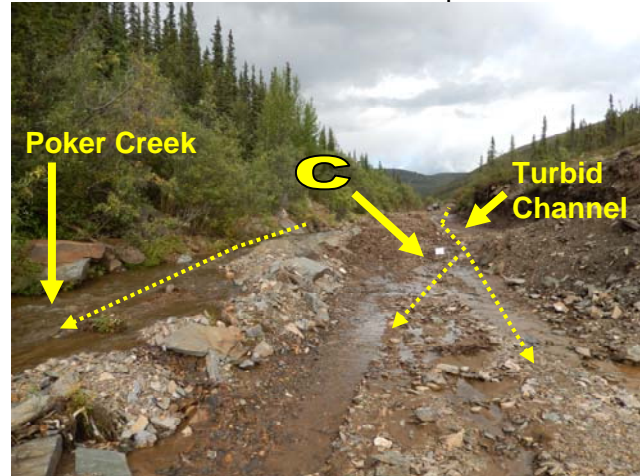
The turbid seepage from the settling pond was observed forming into channels and flowing along the trail until reaching the creek. As the channel left the trail, it flowed through **Sample Station C** where it was sampled immediately before entering Poker Creek on 08/19/13 at approximately 4:36PM. As reported in Section 5 of this report, channel **Sample C** resulted in a reading of **434 NTUs**.⁶

Photograph 11 was taken on 08/19/13 at approximately 4:37 and depicts the channel as it begins to enter Poker Creek through Sample Station C.

Photo 11: Channel flow thru Sample Station C

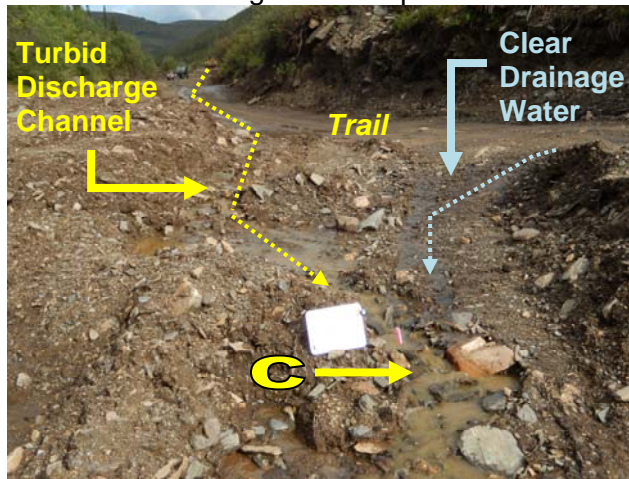
Photograph 12 and **Photograph 13** were taken on 08/19/13 at approximately 4:37PM and depict a channelized turbid discharge as it flowed through **Sample Station C** and into Poker Creek. The turbidity reading at this station was **434 NTUs**. As discussed in Section 3.1 of this report, clear naturally-occurring drainage water can be seen mixing with the volume of turbid discharge water. The clear drainage water appeared to be flowing through Sample Station C from a westerly direction along the trail, which is the opposite direction from where the settling's pond was located.⁷

Photo 12: Discharge channel parallel to creek.

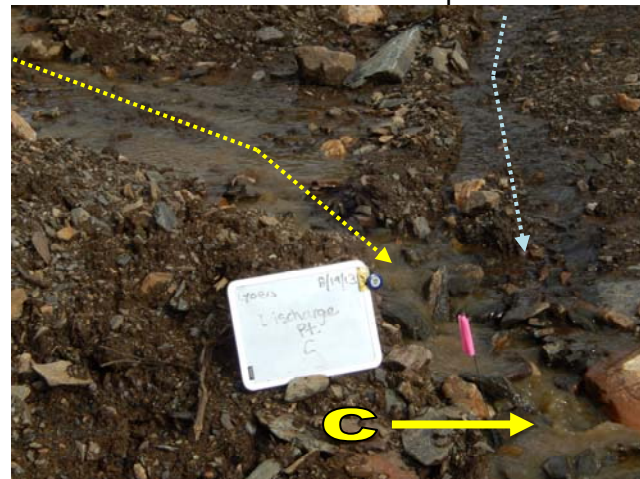
Photo 13: Channel flow thru Sample Station C.

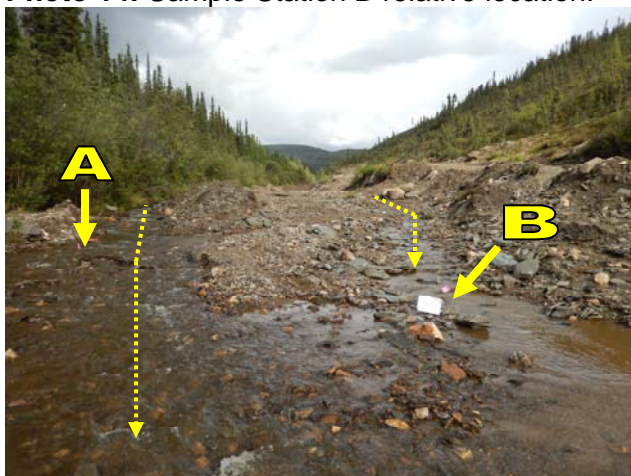
On 08/19/13 at approximately 4:26PM, Special Agent [REDACTED] collected a sample of the discharge as it mixed with the creek. As reported in Section 5 of this report, **Sample B** resulted in a turbidity reading of **136 NTUs**.⁸

Photograph 14 was taken on 08/19/13 at approximately 4:31PM and depicts the location of discharge Sample Station B in relation to Sample Station A.

Photo 14: Sample Station B relative location.

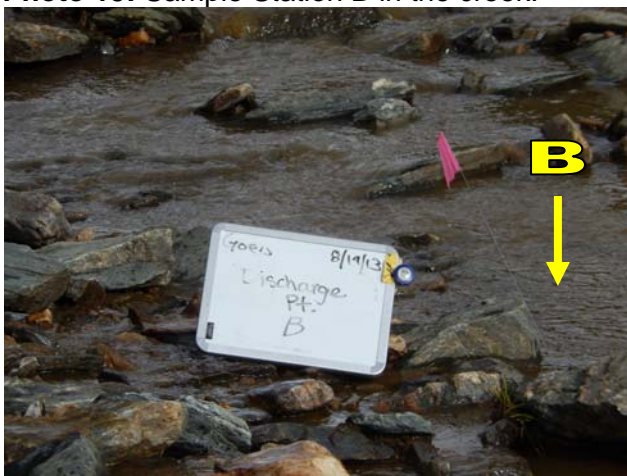
Photograph 15 was taken on 08/19/13 at approximately 4:30PM and depicts a closer perspective of Sample Station B, where the discharge mixes into Poker Creek.

Photo 15: Sample Station B in the creek.

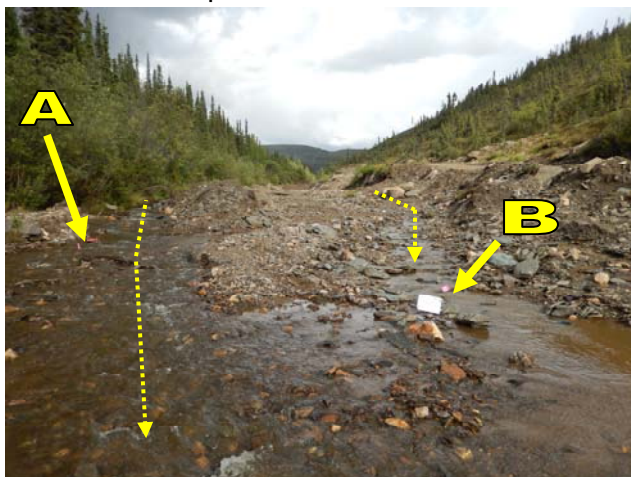
On 08/19/13 at approximately 4:25PM, Special Agent [REDACTED] collected a sample of creek water from Poker Creek, slightly upstream of Sample Station B and downstream of the settling pond. As reported in Section 5 of this report, **Sample A** resulted in a turbidity reading of **12.3 NTUs**.⁹

Photograph 16 was taken on 08/19/13 at approximately 4:31PM and depicts the location of discharge Sample Station A in relation to Sample Station B.

Photo 16: Sample Station A relative location.

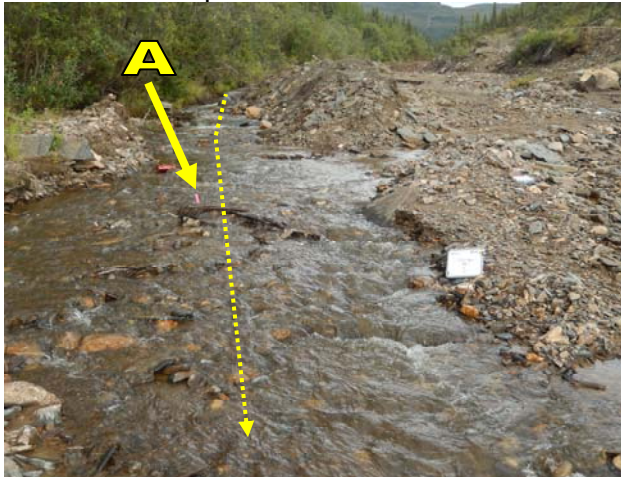
Photograph 17 was taken on 08/19/13 at approximately 4:28PM and depicts the location of Sample Station A in Poker Creek, downstream from the settling pond.

Photo 17: Sample Station A in the creek.

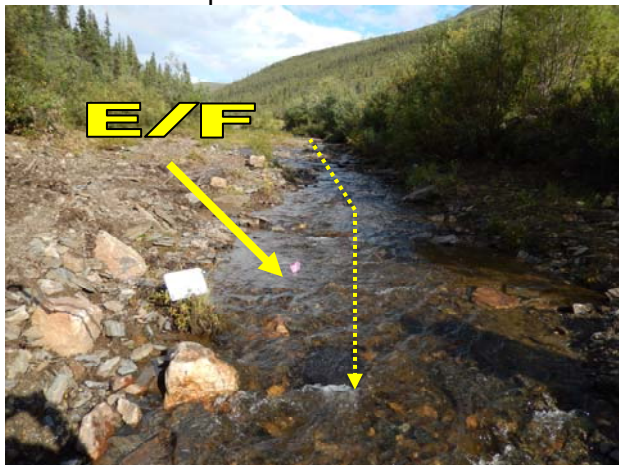
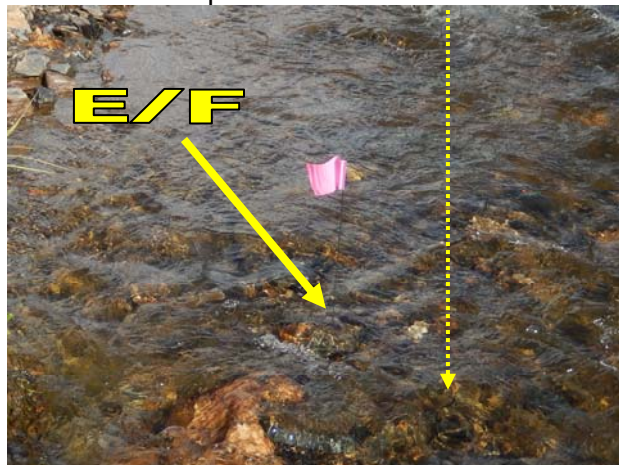
On 08/19/13 at approximately 4:52 PM, background turbidity was measured at **Sample Station E/F**, located approximately 150 yards upstream of Sample Station D and upstream of the mine's washplant and discharge channels into Poker Creek. As reported in Section 5 of this report, replicate **Sample E** resulted in a reading of **3.51 NTUs** and replicate **Sample F** resulted in a reading of **2.33 NTUs**.¹¹

Photograph 18 and **Photograph 19** were taken on 08/19/13 at approximately 4:53PM and depict the location from where replicate Sample E and replicate Sample F were collected.

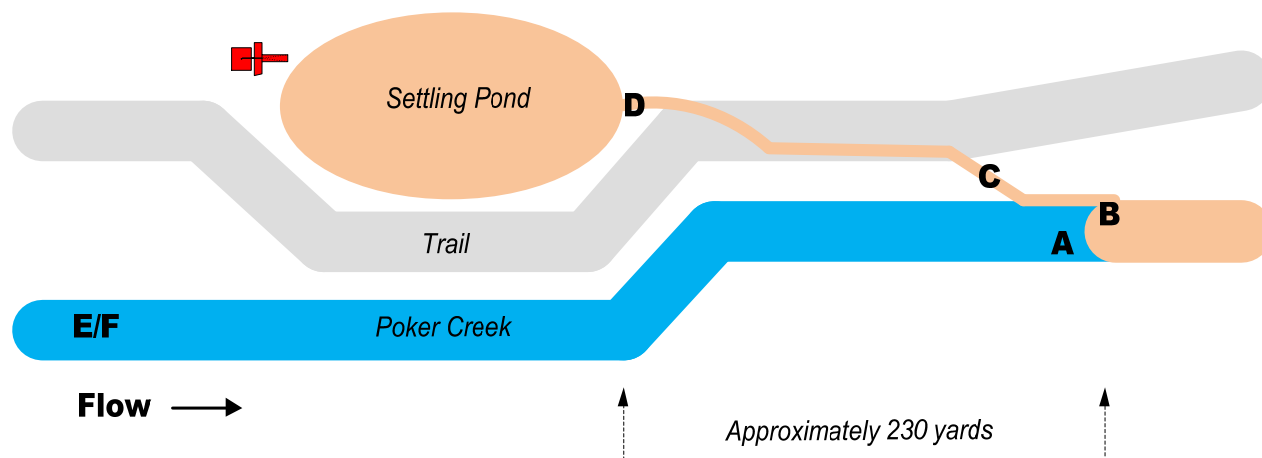
Graphic 1: Sample Stations

Graphic 1 below is provided for reference and depicts the relative location of sample stations to the point of discharge into Poker Creek. The graphic is not drawn to scale.

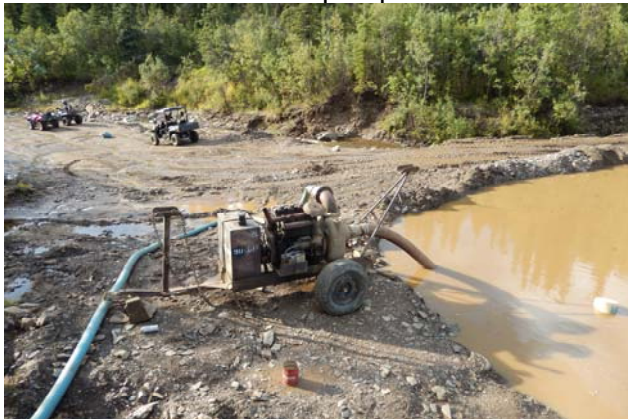
Photograph 20 was taken on 08/19/13 at approximately 5:38PM and depicts the beneficiation water pump apparently configured to recirculate water from the settling pond to the washplant. **Photograph 21** was taken on 08/19/13 at approximately 5:35PM and depicts the washplant. **Photograph 22** represents a frame from video recording DSCN2153 taken on 08/19/13 at approximately 4:45PM and depicts the surface of the settling pond, the pump, and the washplant.

Photo 20: Beneficiation pump.

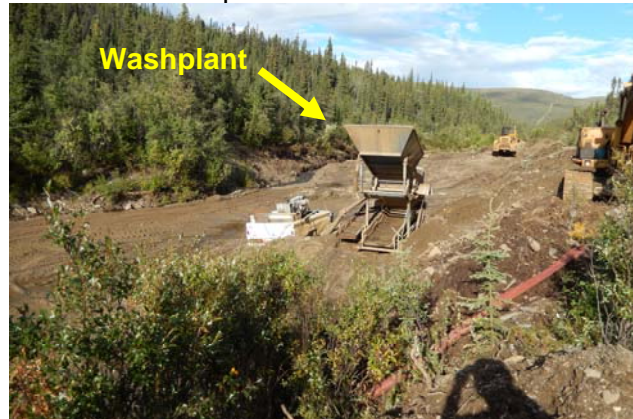
Photo 21: Washplant

Located on the eastern bank of the settling pond was a washplant and excavator. The washplant was not operating when investigators arrived and did not operate while investigators were present. Located on the western bank of the settling pond was a wheeled water pump with a tan-colored hose placed into the settling pond. Leading from the pump toward the washplant was a long blue-colored hose. Based on this configuration, it appeared to Special Agent [REDACTED] that the pump was configured to recirculate water from the settling pond for the washplant's beneficiation process.

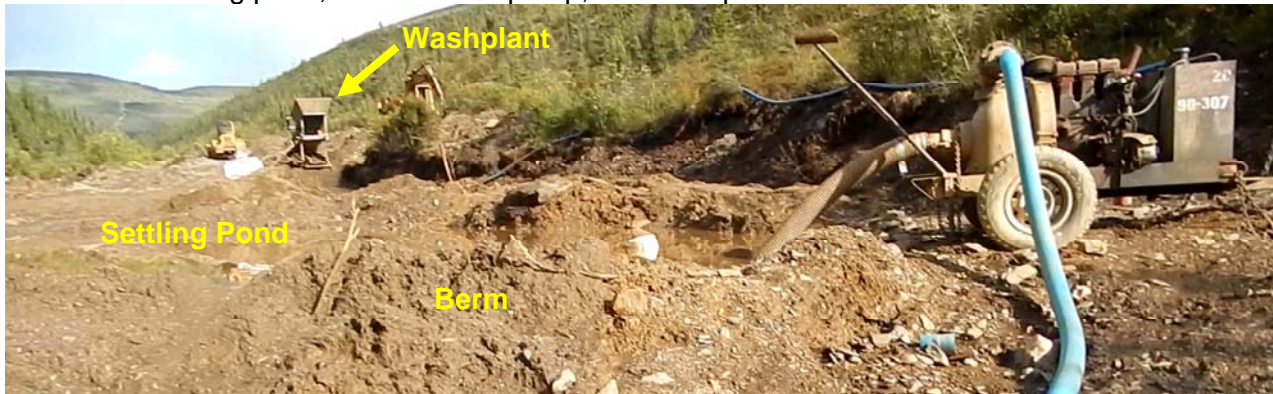
Photo 22: Settling pond, beneficiation pump, and washplant.

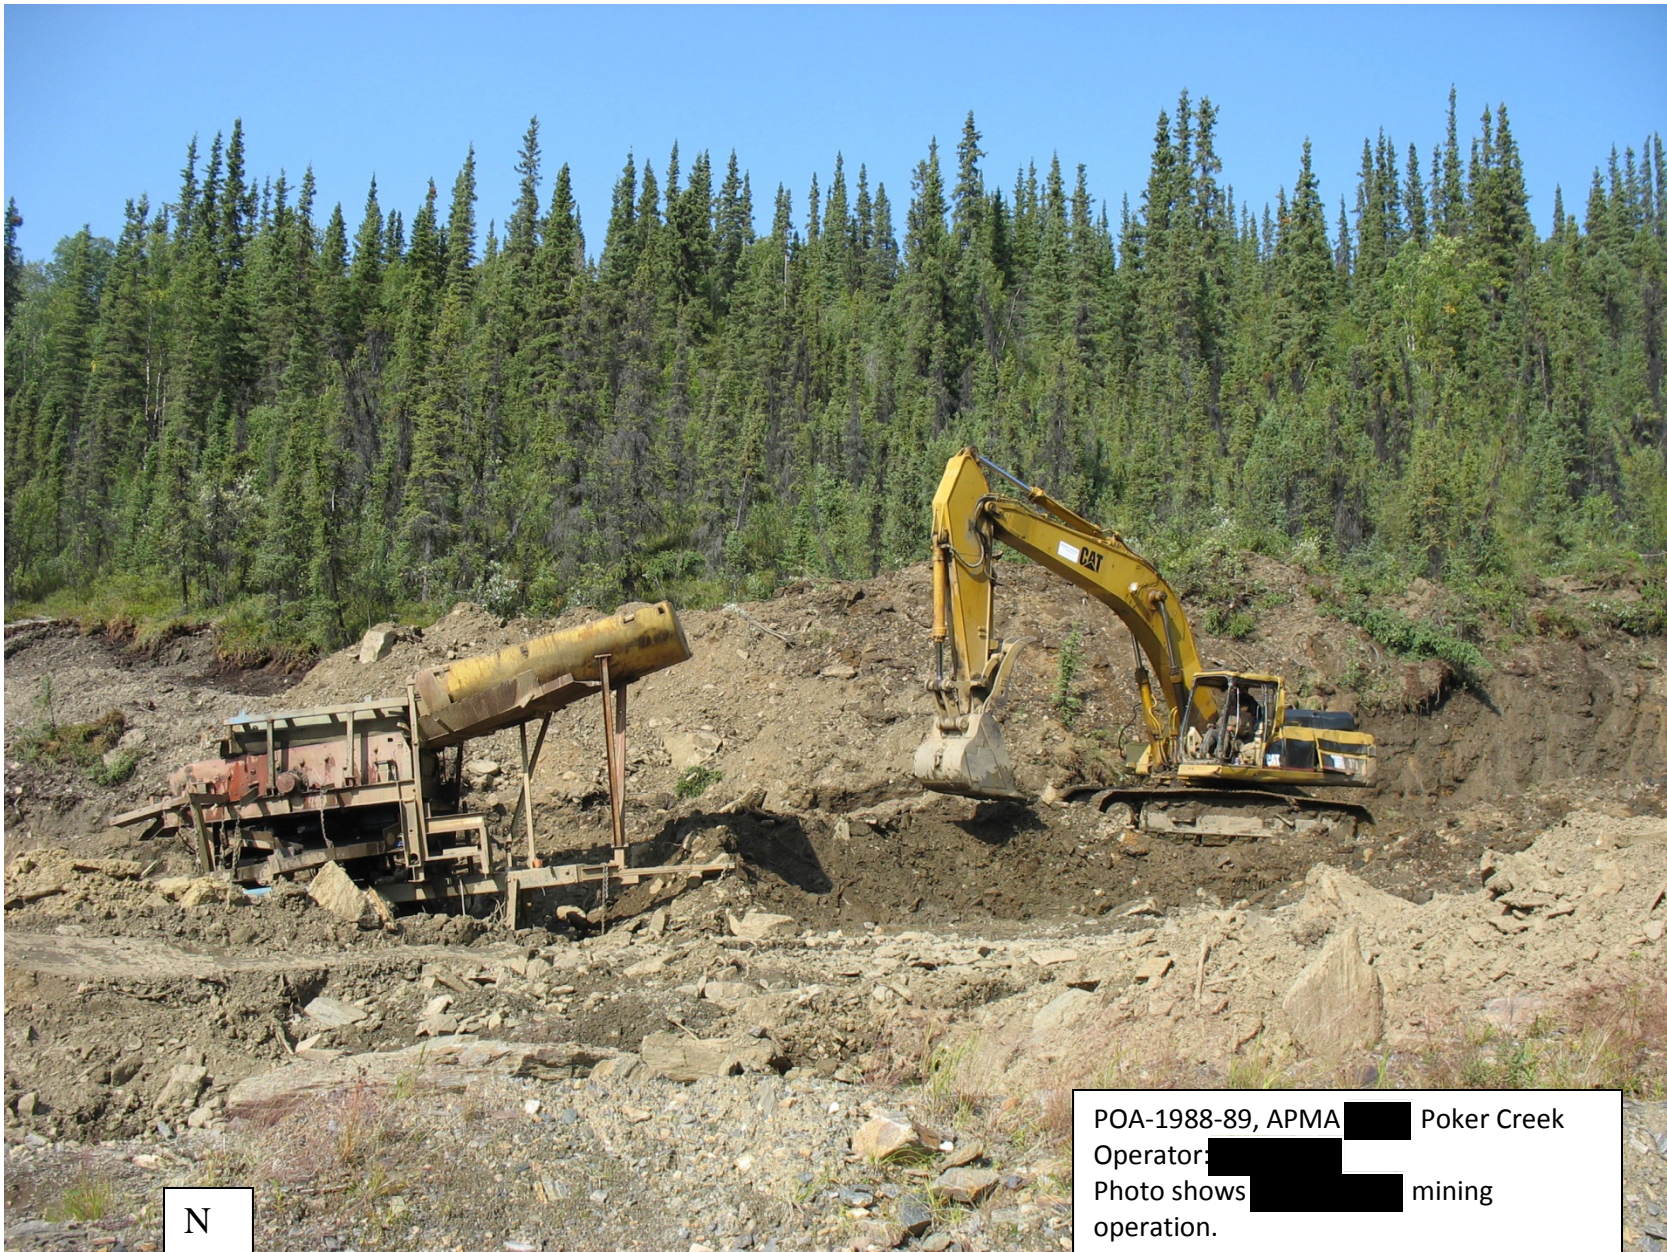
POA-1988-89, APMA [redacted] Poker Creek
Operator: [redacted]
Photo shows [redacted] mining operation. Blue vehicle is where we parked the state of Alaska vehicle, below the operations. The Poker Creek Valley is fairly narrow and steep, ~ 10% grade, valley bottom . Mining is occurring at the toe of slope on both sides of the valley. Creek is diverted to either one side or the other of the valley. In this photo, creek is on the left limit. The road is up the middle of the valley.
Photo 1

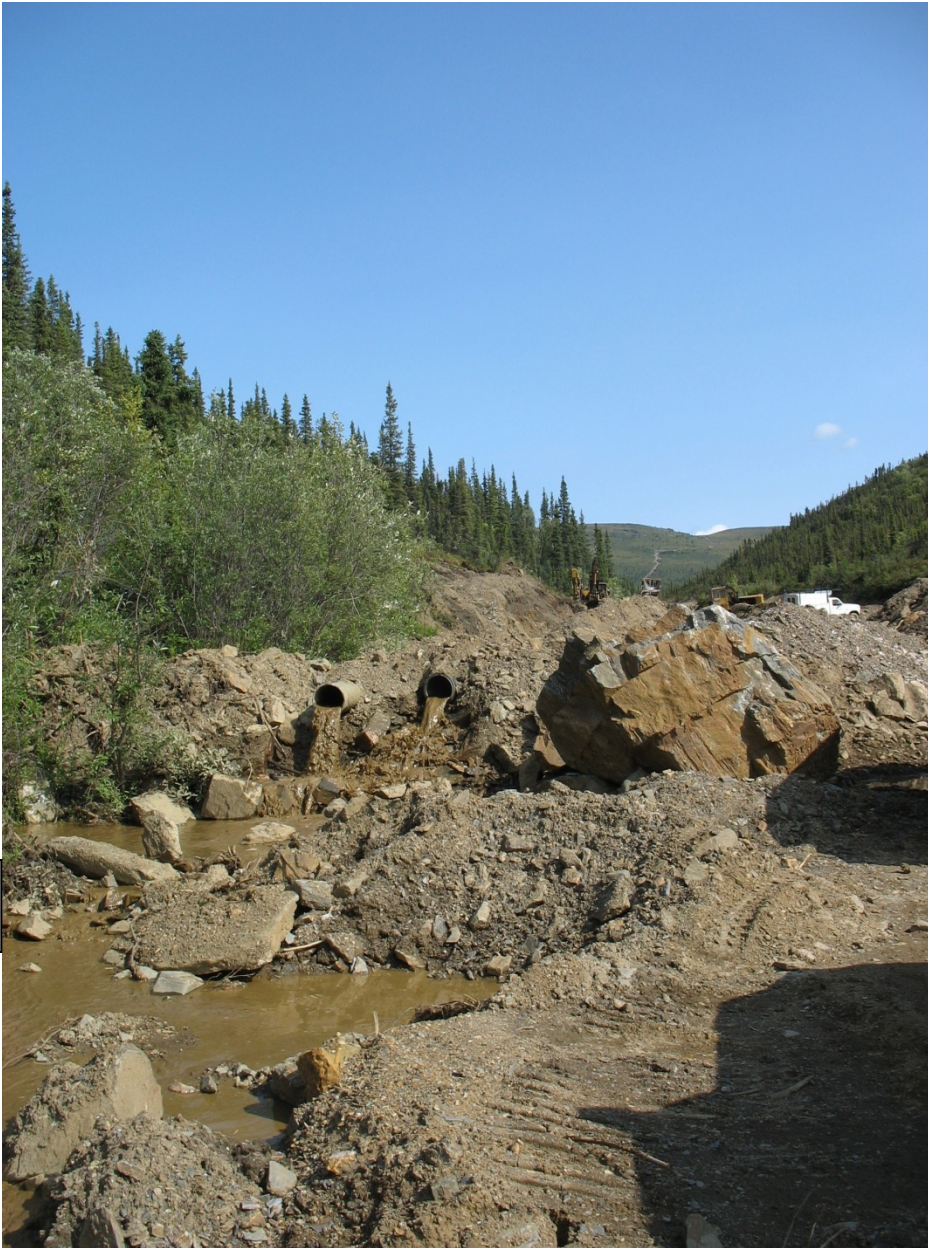
POA-1988-89, APMA [REDACTED] Poker Creek
Operator: [REDACTED]
Photo of settling pond on right limit, below mining
operation. Water is running.
Photo 6

right limit
settling pond

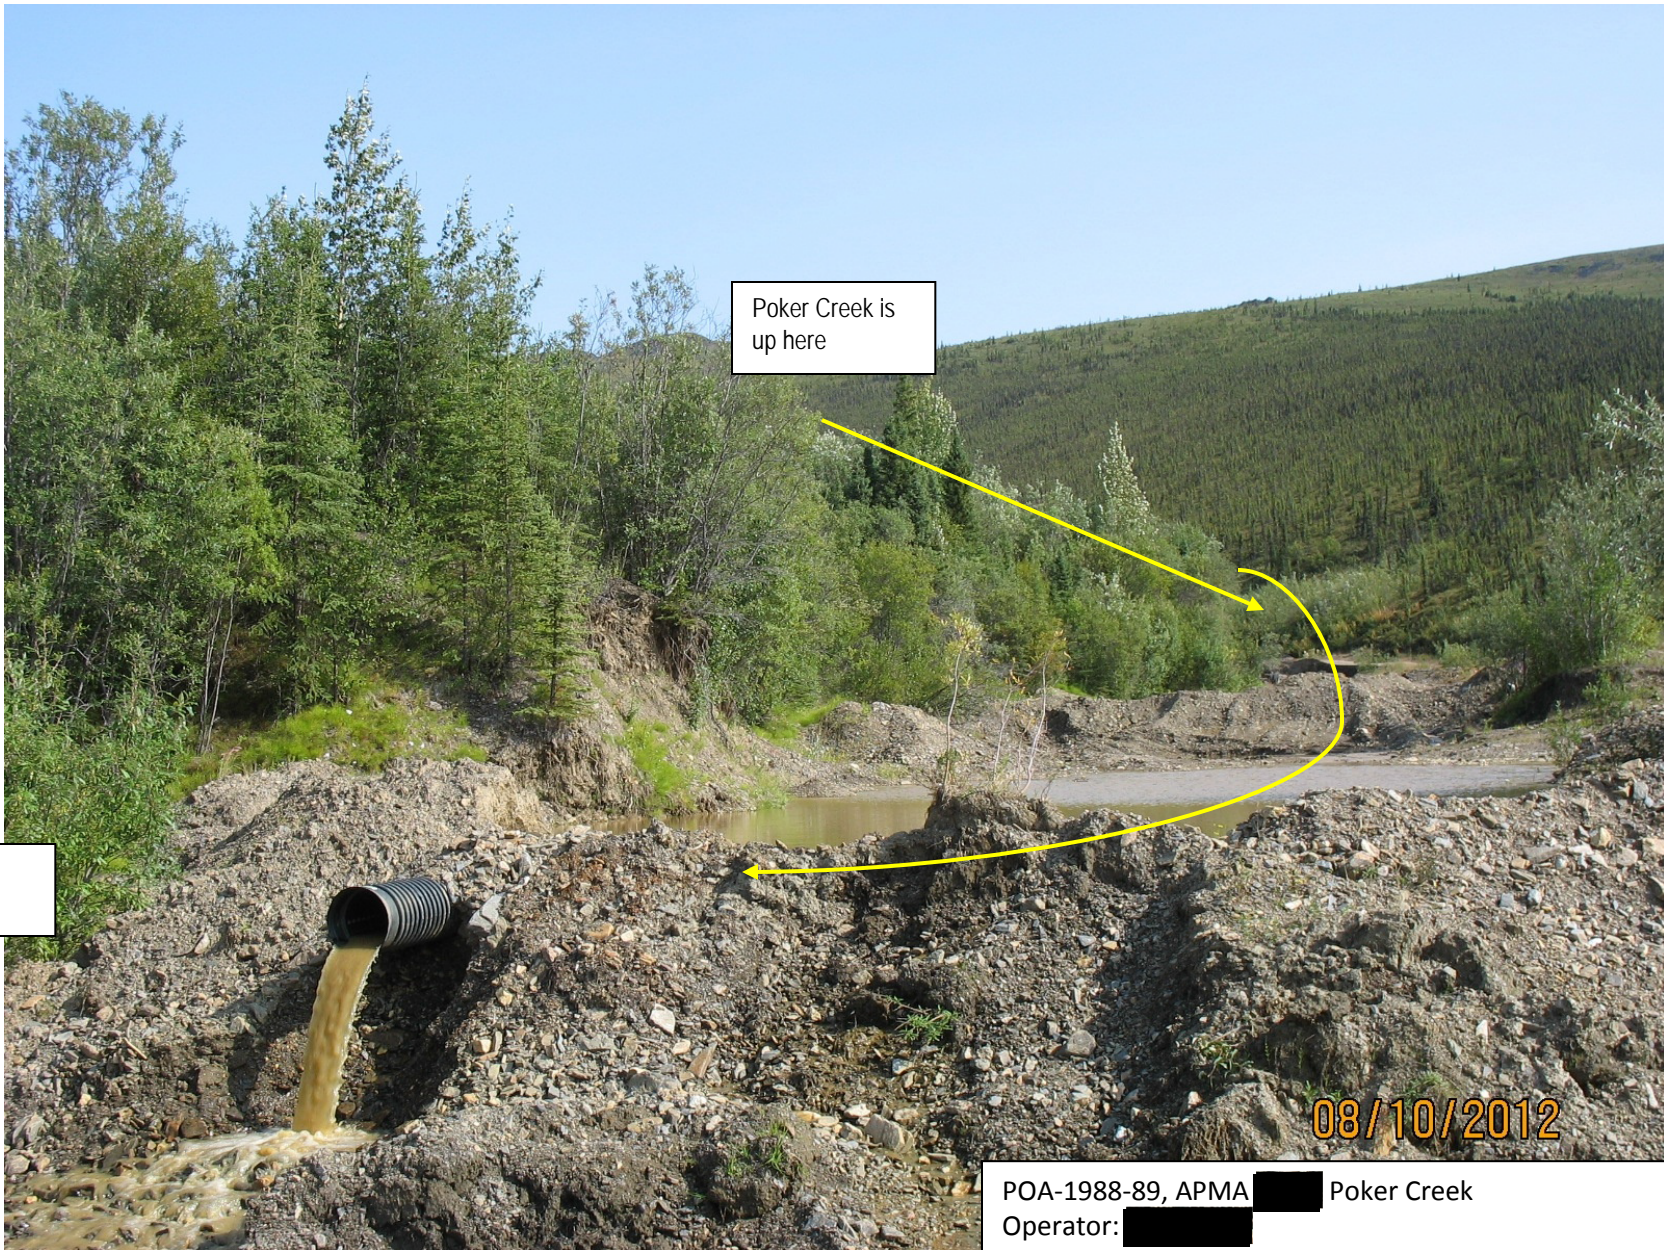
Photo 7

Photo of another settling pond on right limit, below previous settling pond and mining operation. Water is running.

right limit
settling pond

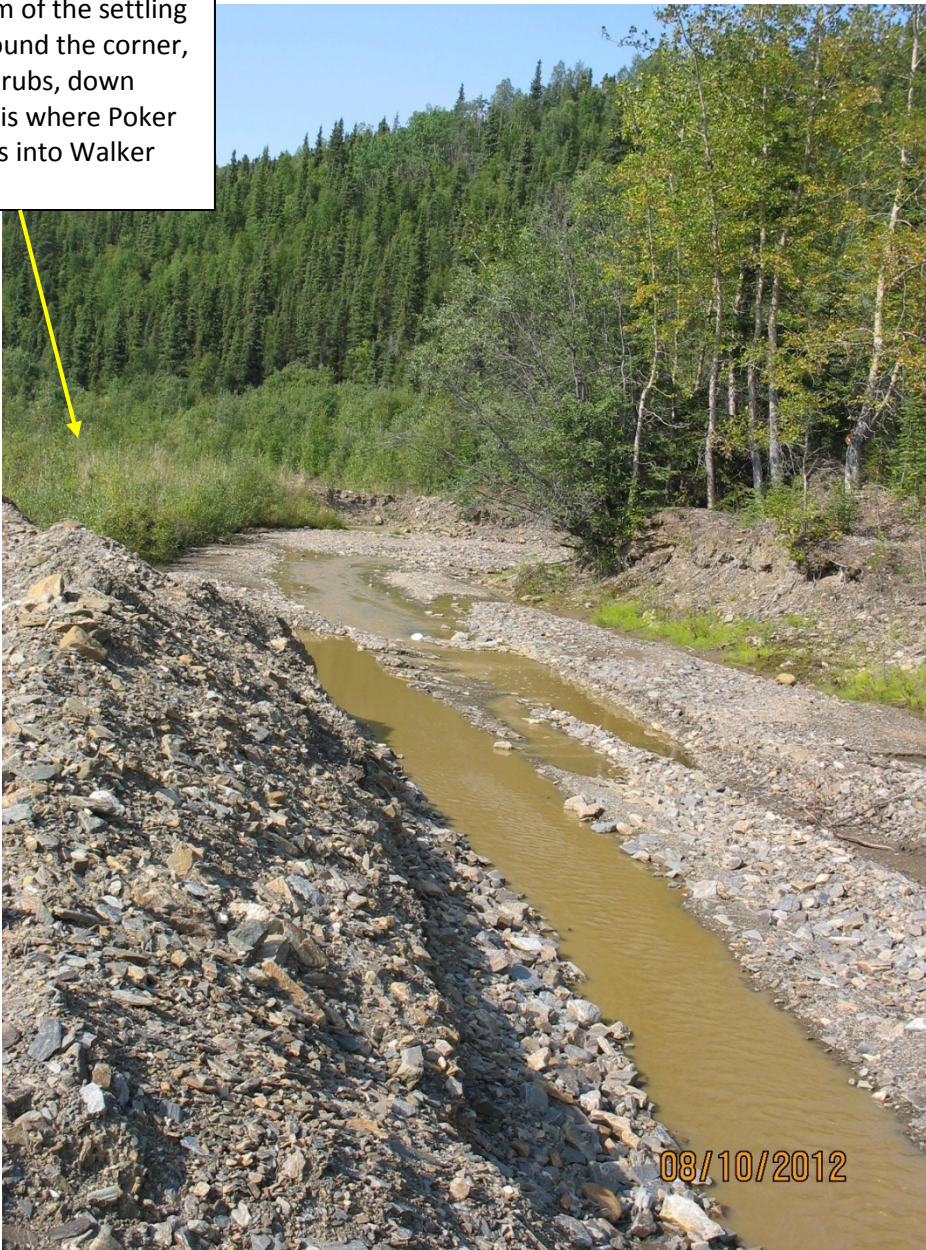
Photo 8

This bottom of the settling pond is around the corner, of these shrubs, down here. This is where Poker Creek flows into Walker Fork.
